**PRELIMINARY ASSESSMENT/
VISUAL SITE INSPECTION**

**REYNOLDS METALS COMPANY
ASHVILLE, OHIO
OHD 055 352 512**

FINAL REPORT

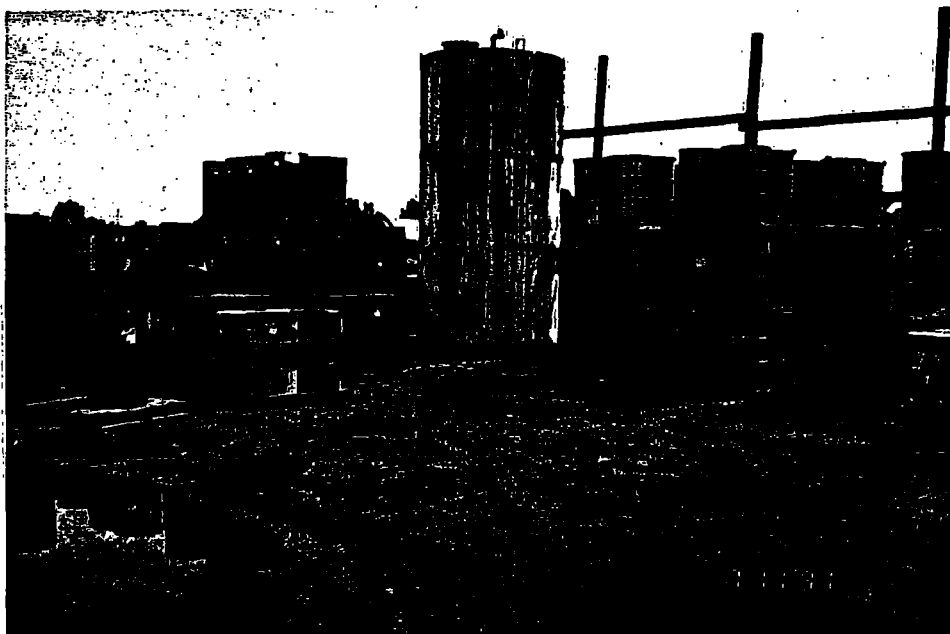
Photograph No. 1

Location: SWMU 1

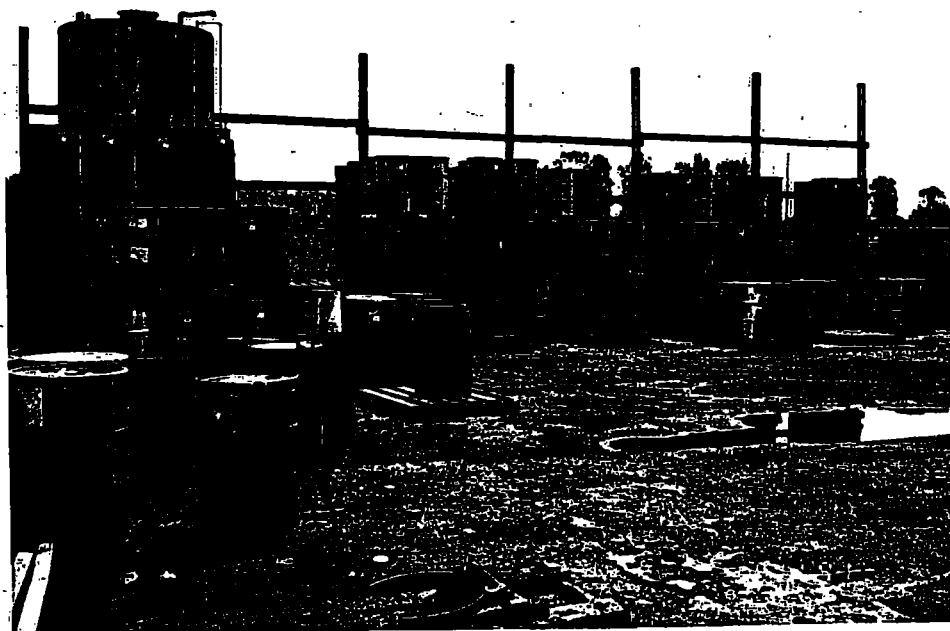
Photograph No. 2

Location: SWMU 1

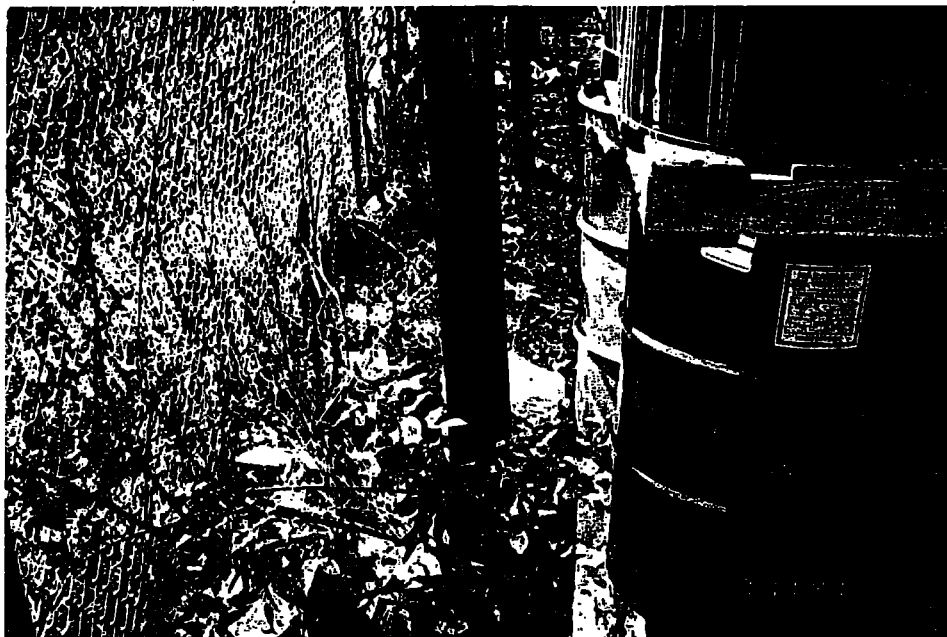
Photograph No. 3

SWMU 1	Waste Storage Area
Unit Description:	The less than 90-day waste storage area is located on the northeast side of the Reynolds manufacturing building. This outdoor area has an unbermed, uncovered, asphalt pad. It stores empty drums, drums filled with hazardous waste, and drums filled with nonhazardous waste (see Photograph Nos. 1 and 2).
Date of Startup:	This unit started operating in 1972.
Date of Closure:	This unit is currently operational. A closure plan for the area was unavailable at the time of the file review.
Wastes Managed:	All full drums of hazardous paint wastes and solvents are stored at this location until they are removed for disposal. The area also houses waste oils.
Release Controls:	The area has an uncovered, unbermed, asphalt pad.
History of Release:	No releases from this unit have been documented.
Observations:	During the VSI, about 100 55-gallon drums of waste were in the unit and the asphalt surface was worn and stained. Nearby vegetation was stressed, although PRC could not determine whether this was caused by releases from the unit (see Photograph No. 3). No stained soil was noted.

Description: This is the region behind the waste storage area. About 10 feet to the left (east) of the chain-link fence is a drainage ditch.

Recommendations: PRC recommends that Reynolds provide sufficient containment for waste storage to prevent spill and storm water runoff releases. Soils in the vicinity of the unit should be sampled and analyzed for hazardous constituents.
